**WINDSOR FARRINGTON PARK LAKE DAM**

**PETTIS COUNTY, MISSOURI**

**MO 20834**

**PHASE 1 INSPECTION REPORT  
NATIONAL DAM SAFETY PROGRAM**

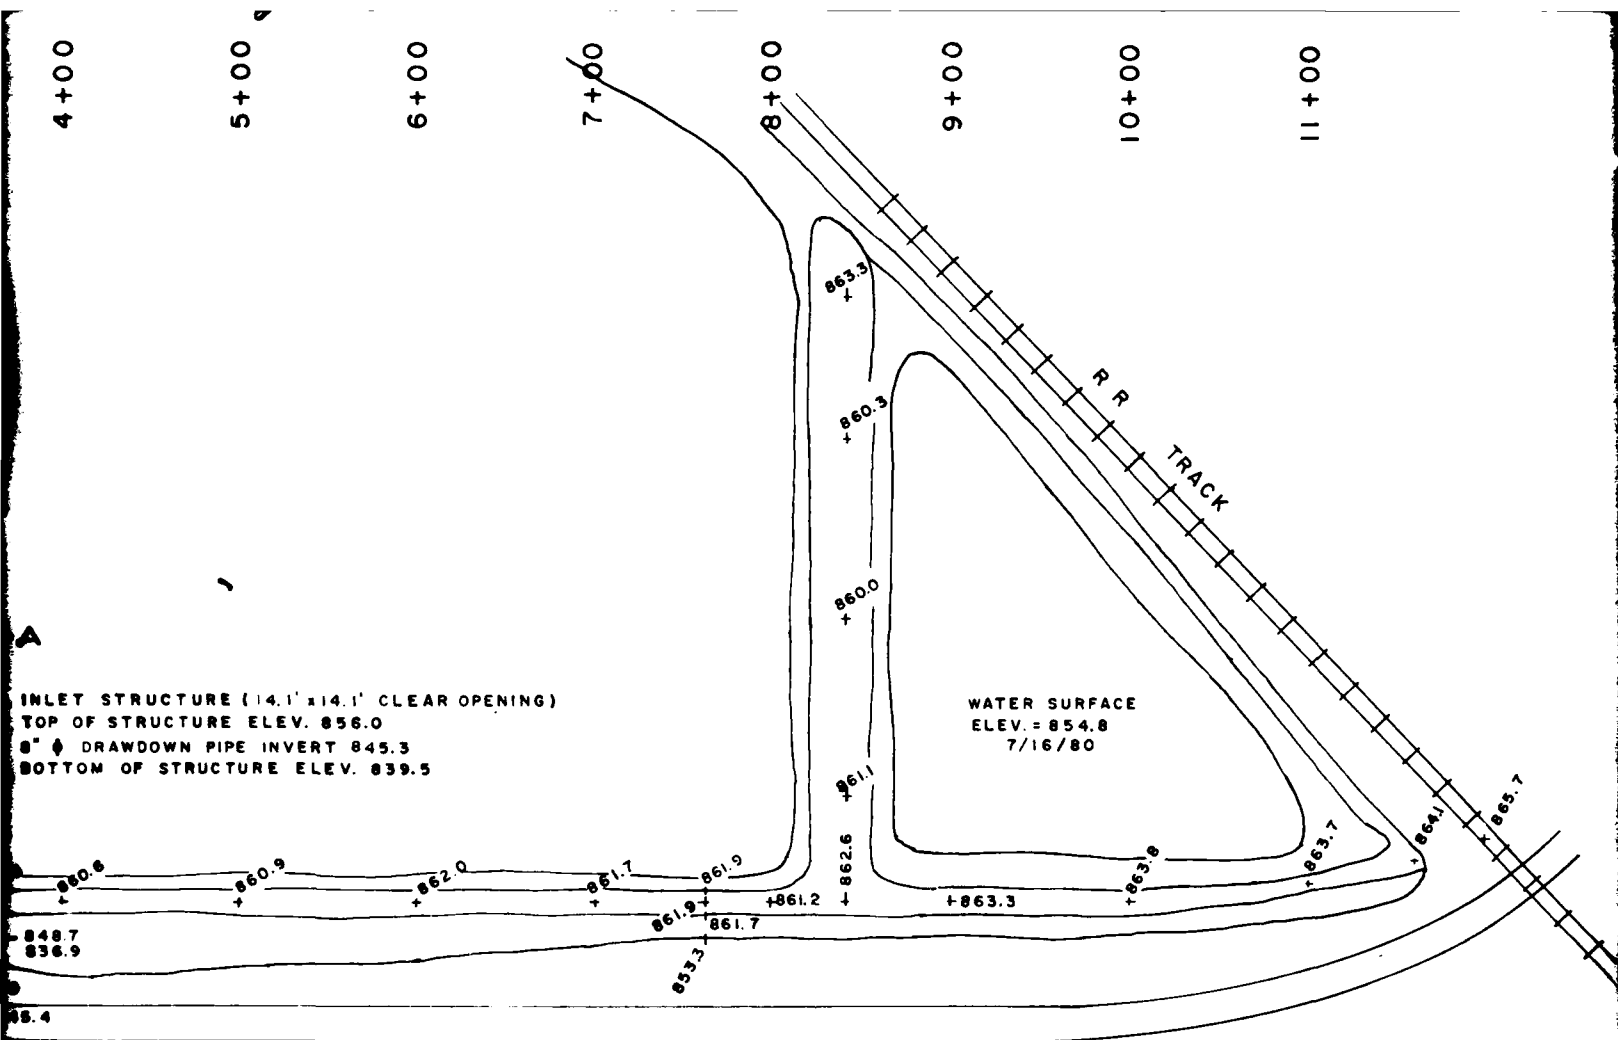
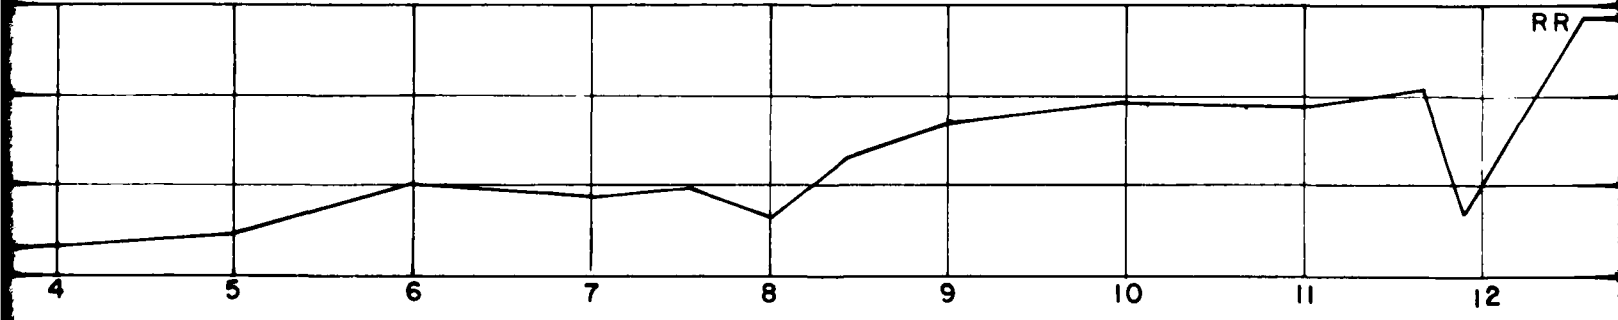
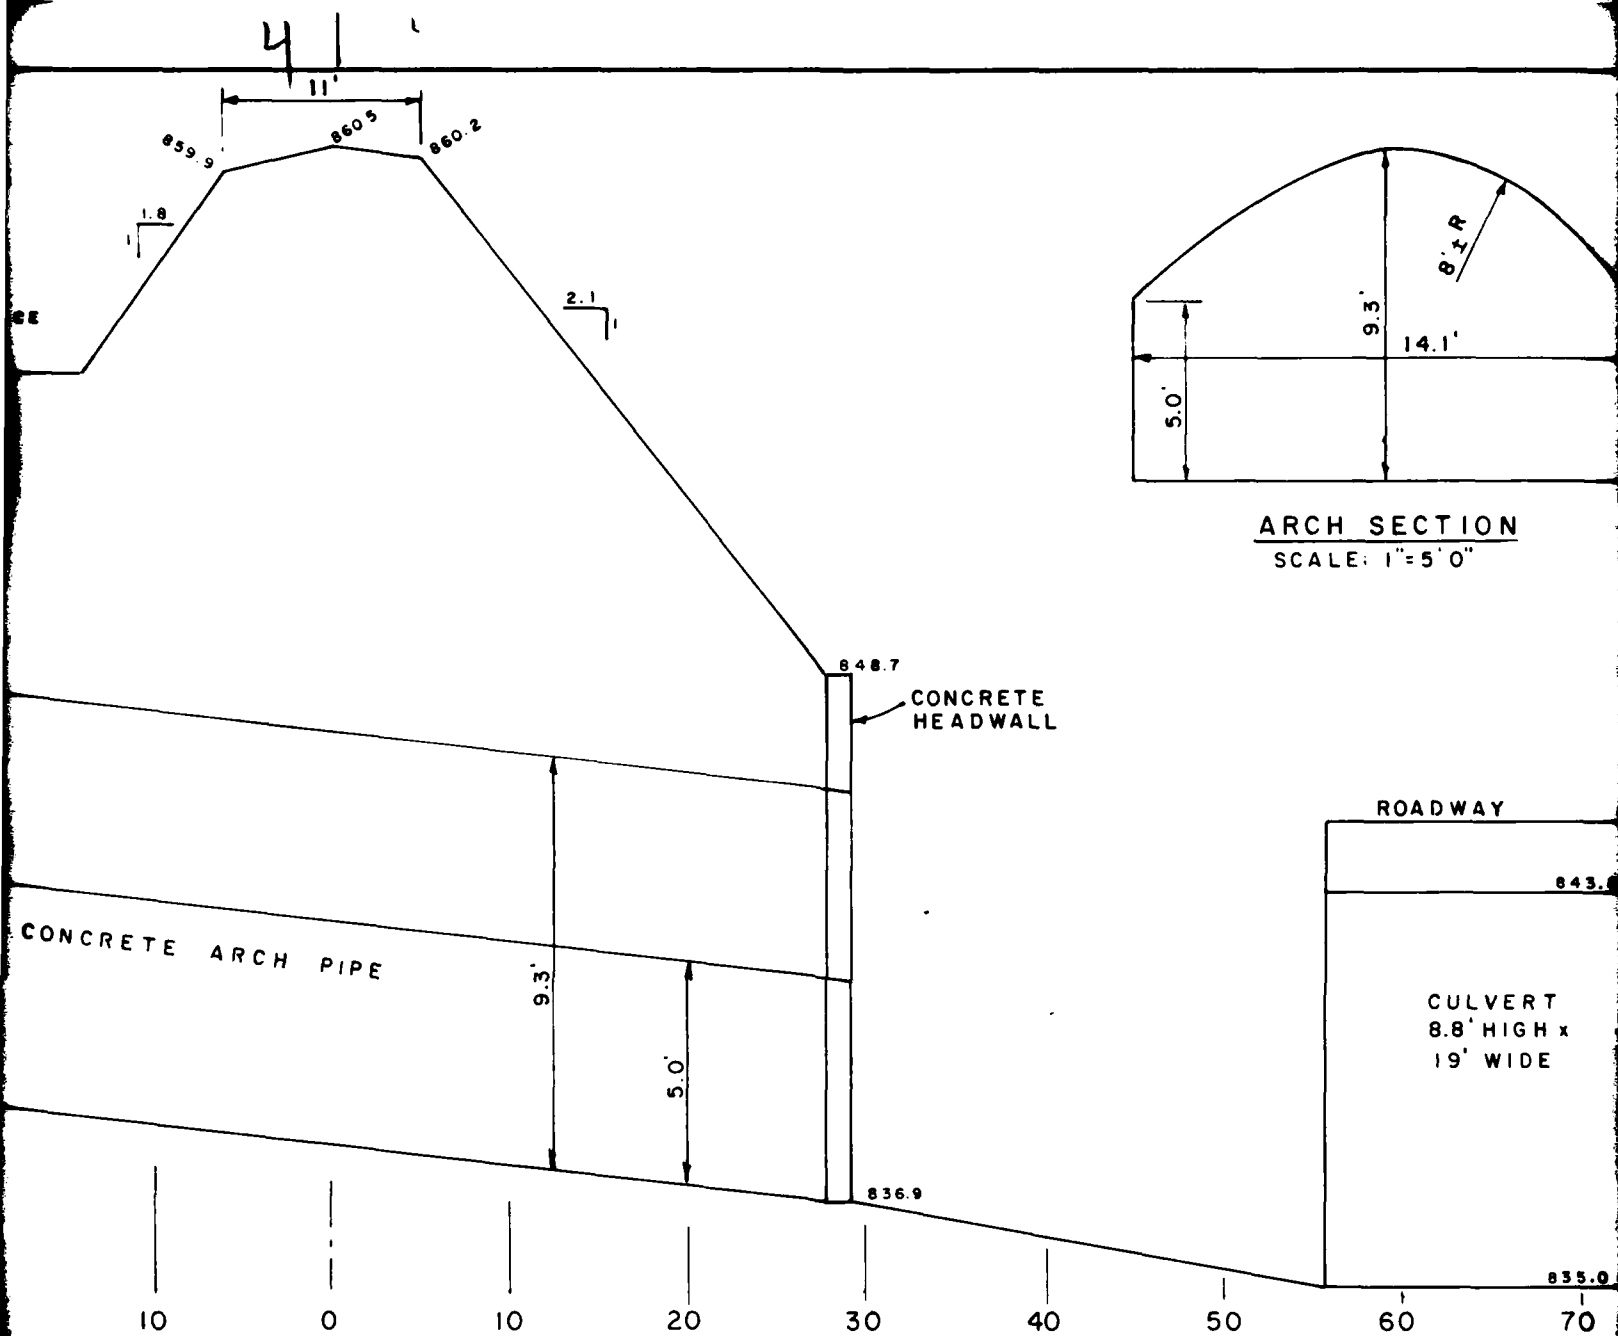
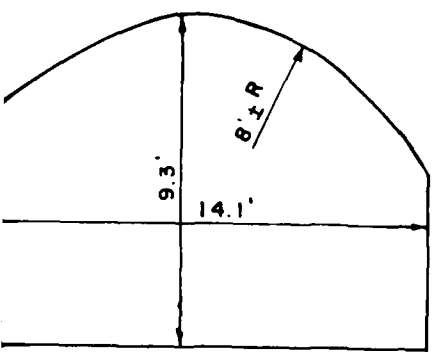
PLAN & PROFILE

Sheet 3 of Appendix A shows a plan, profile, and typical section of the embankments and details of the inlet structure and the arch culvert.
